# **Intel<sup>®</sup> Pentium<sup>®</sup> III Xeon<sup>™</sup> Processor Specification Update**

Release Date: October 2000

Order Number: 244460-021

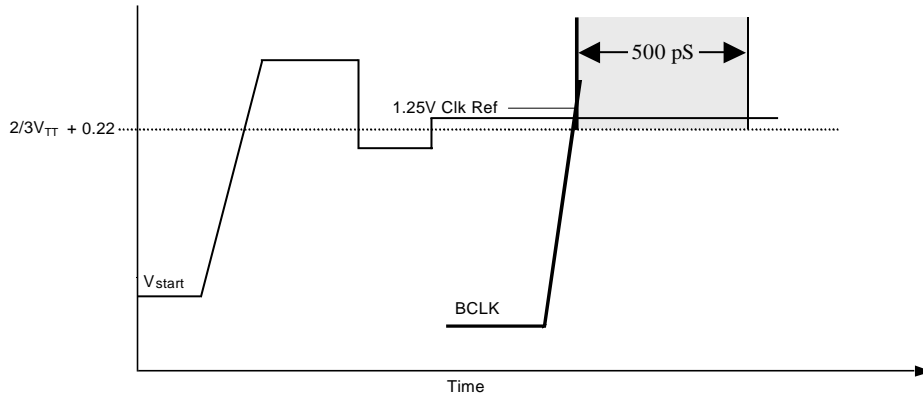
The published AGTL+ AC specification for  $V_{IH(MIN)}$  is  $(2/3 \cdot V_{TT}) + 0.1$  Volts.

Intel has characterized the new AGTL+ AC specification for  $V_{IH(MIN)}$  on the processor's RS0# signal to be:  $(2/3 \cdot V_{TT}) + 0.22$  Volts within 500 picoseconds following the rising edge of BCLK crossing the 1.25-Volt threshold. See below.

**Implication:** The deviation from the published specification results in decreased noise margin on the RS0# processor input. This decreased noise margin has been observed to be particularly detrimental in system environments where the RS0# processor input is being driven by an I/O buffer with a pull-up device (such as a p-channel transistor) that is switched off mid-cycle. Systems that employ I/O buffers that keep the pull-up device on for the entire cycle are significantly less affected by this erratum. The reduction in noise margin may lead to the generation of BINIT# (when enabled) resulting in a system reset, otherwise this condition may lead to a system "hang" condition.

**Workaround:** If a system design cannot meet the specification deviation, the following areas should be carefully examined to assure that additional margin exists in order to compensate for any deficit observed with respect to the newly characterized  $V_{IH(MIN)}$  specification:

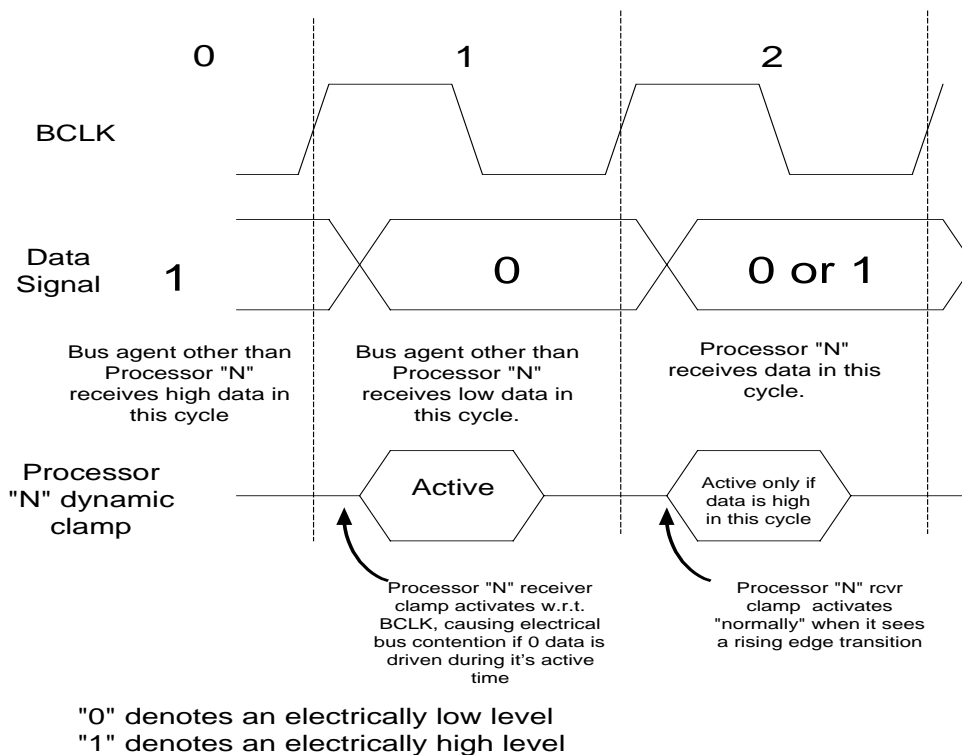
**Problem:** Falling edge ledge push-out and undershoot may be seen on AGTL+ data and data bus ECC signals. The AGTL+ receiver's dynamic clamp circuit activates (i.e. clamps the signal to an electrically high level) in certain cycles when data is driven to an electrically low level by another agent.

**Implication:** This erratum only occurs on a processor that does not receive data in that particular cycle. More specifically, this erratum only occurs when a specific processor does not receive data in the current BCLK period, but receives data in the very next period. Therefore, the processor inducing this falling edge noise (on data and data bus ECC signals) will not actually read the data in that cycle. See below for an illustration of this erratum affecting a processor denoted Processor "N". The falling edge ledges and undershoots may affect the signal quality and/or timing at agents that receive data in that cycle. Therefore, the impact of this erratum is highly dependent on system bus design.

**Workaround:** Evaluate system bus signal quality and timing margin at the valid receiving agent as a result of this falling edge noise. Due to dependence upon system bus design, bus layout may be evaluated to determine the need for improvements in signal quality and timing margin at the valid receiving agent as a result of this receiver-induced falling edge noise.
